**CONDITION ASSESSMENT OF HISTORIC BUILDINGS: CASE OF
ISA BEY BATH IN NOVI PAZAR, SERBIA**

**TARİHİ YAPILARIN MEVCUT DURUM DEĞERLENDİRMESİ:
SİRBİSTAN, YENİ PAZAR İSA BEY HAMAMI ÖRNEĞİ**

*Gülşen DİŞLİ**

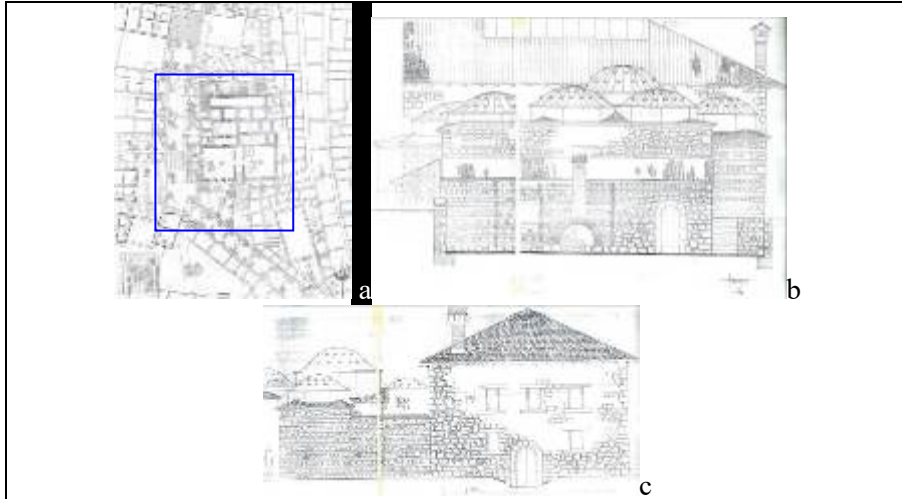
Figure 6: Plan drawing (a) and South facade (b) of the building and drawing of the east facade of the building (c) (Source: Archives of Novi Pazar Municipality, 2009, prepared by Ukić Redžep in 1994)

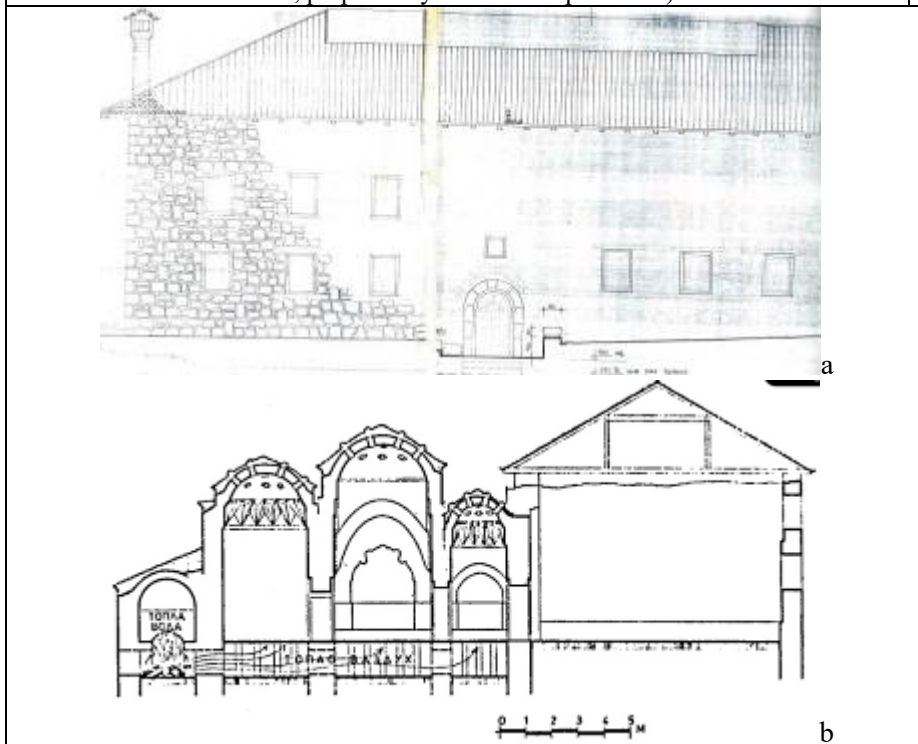
Figure 7: North façade drawing of the bath (a) & its longitudinal section (b) (Source: (a) Archives of Novi Pazar Municipality 2009, prepared by Ukić Redžep in 1994, (b) Rašković and Milović, 1975, 137-144).
